**LOWER HART POND DAM
CT 00247**

**PHASE I INSPECTION REPORT
NATIONAL DAM INSPECTION PROGRAM**

FEBRUARY, 1981

Identification Number:	CT 00247
Name:	Lower Hart Pond Dam
City:	Berlin
County and State:	Hartford County, Connecticut
Stream:	Mattabasset River
Date of Inspection:	October 21, 1980

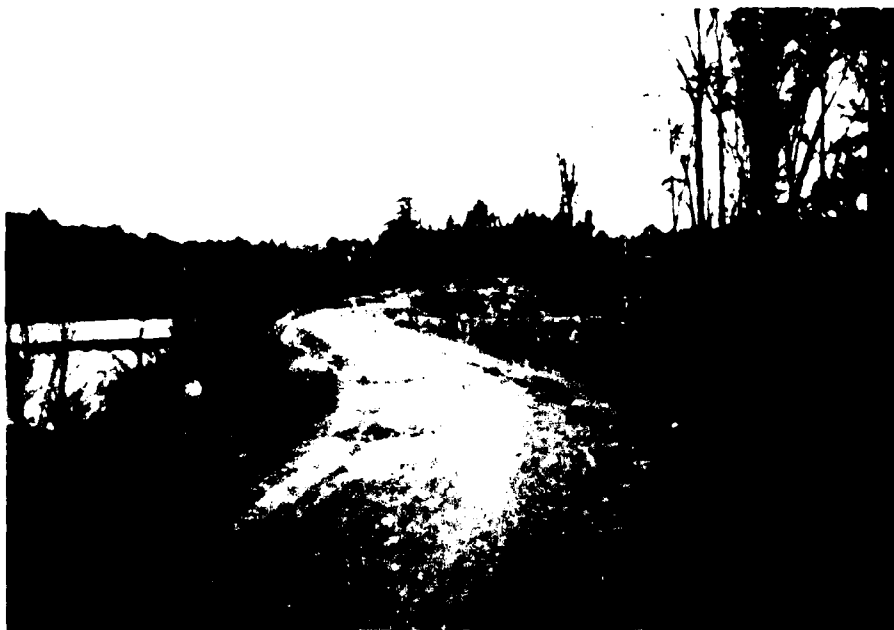
PHOTO 1
TOP OF DAM LOOKING NORTH

b. Dam - The dam is an earth embankment. The downstream face is well vegetated with grass and some brush (Photos 1 and 3) and the slopes are 2.5:1. Along the toe of the dam, there are trees and brush which obscured the view of the toe (Photos 1 and 3). The upstream face is in good condition with no signs of distress. Also, there are several areas on the upstream embankment where brush and small trees are growing (Photos 1 and 2). The riprap protection shows no signs of erosion or sloughing (Photo 2). Along the southern abutment of the spillway and on the upstream face of the dam, there is evidence of erosion from rain water running off the top of the dam. The top of the dam is level with no signs of settlement.

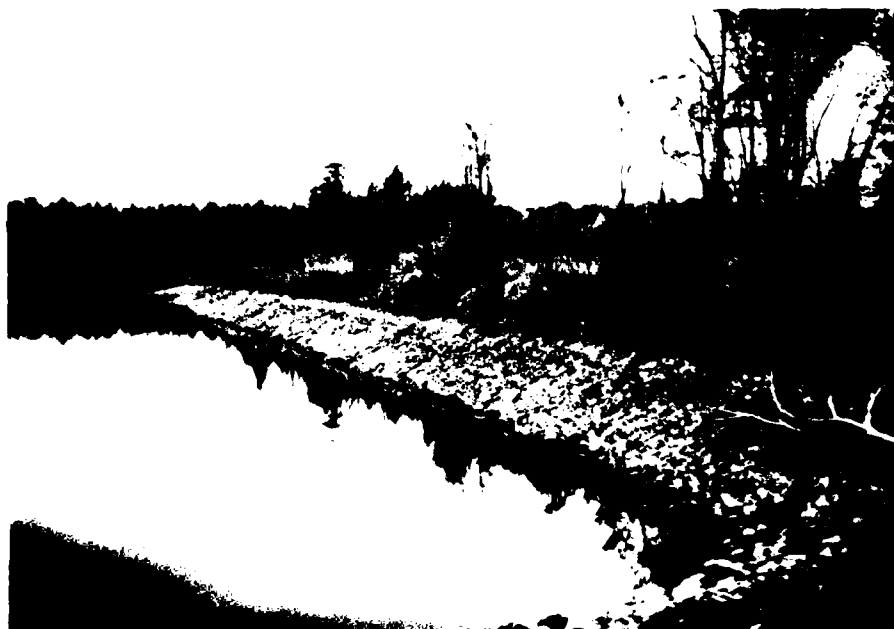
PHOTO 2
UPSTREAM FACE OF DAM

The general structural stability of the dam is good as evidenced by the vertical, horizontal and lateral alignment of the embankment. The embankment has a good vegetative cover and the riprap protection on the upstream face is in good condition. The spillway channel is in fair condition with several areas that are being undermined. Presently, this condition is not detrimental to the spillway structure, but continued undermining will create future problems.

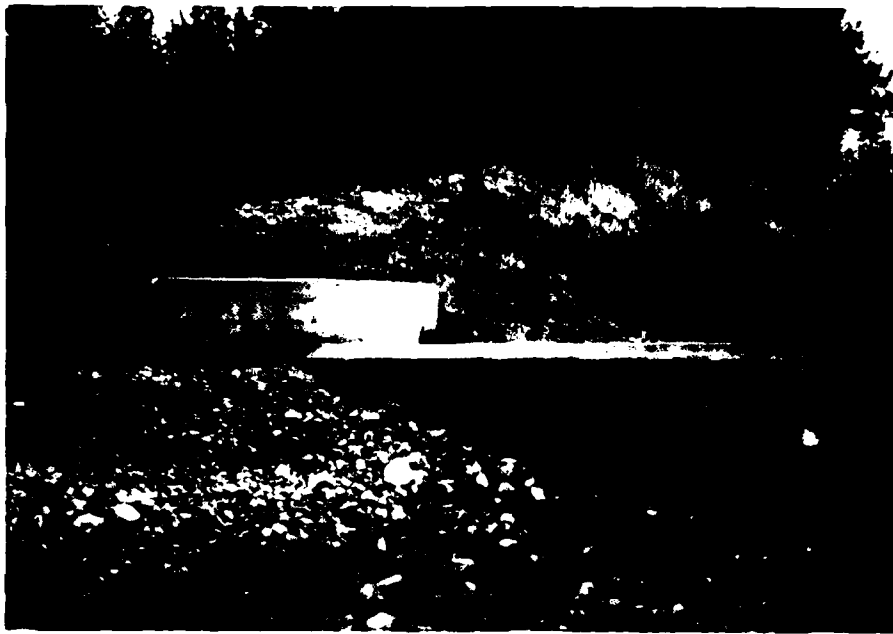
PHOTO 7

The spillway is a concrete ogee weir that is in fair condition (Photos 5 through 9). The downstream channel is a bedrock channel that is 30 feet wide. The south side of the channel has a concrete training wall approximately 100 feet long. The downstream side of the spillway is being undermined and an attempt to correct the problem with concrete has been made (Photo 6). There is also some undermining at the spillway's north abutment (Photo 7). The downstream spillway training wall is in fair condition and in one spot it to is being undermined (Photo 5).

SPILLWAY - NORTH ABUTMENT - UPSTREAM FACE
